Data on the Danish West Coast

PEM - Pressure Equalizing Modules and their performance on the high energy Danish West Coast.

This document provides basic data on sites in Denmark where the PEM system - Pressure Equalizing Modules - has been tested or installed.

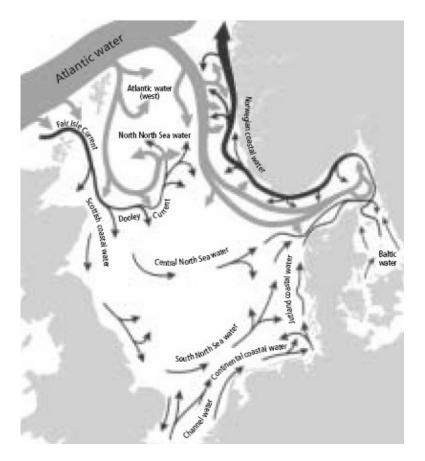
Fig 7. Net currents in the North Sea
